Sears Pond Project Update

Lewis County Soil and Water Conservation District
Nichelle Billhardt
District Manager
376-6122

“Brook Trout Habitat Enhancement”

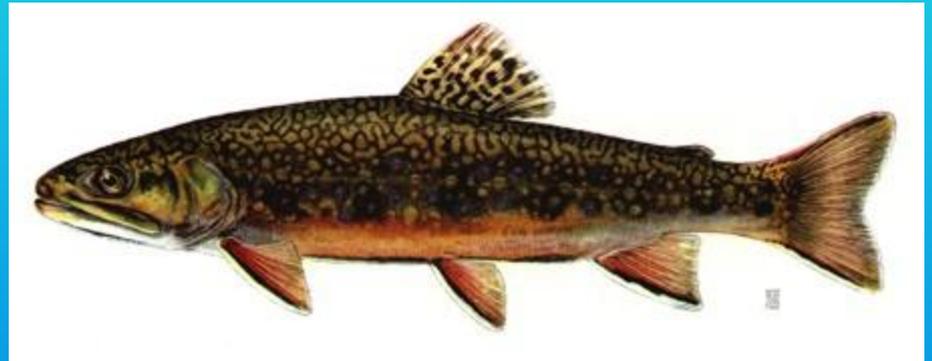
Project Outline

- Pre-Project Stream Health Assessment
- Trail Construction
- Adjust Dam Height
- Tree Planting
- J-Hook / Rock Vane Installation
- Post Structure Evaluation
- Post Project Stream Health Assessment

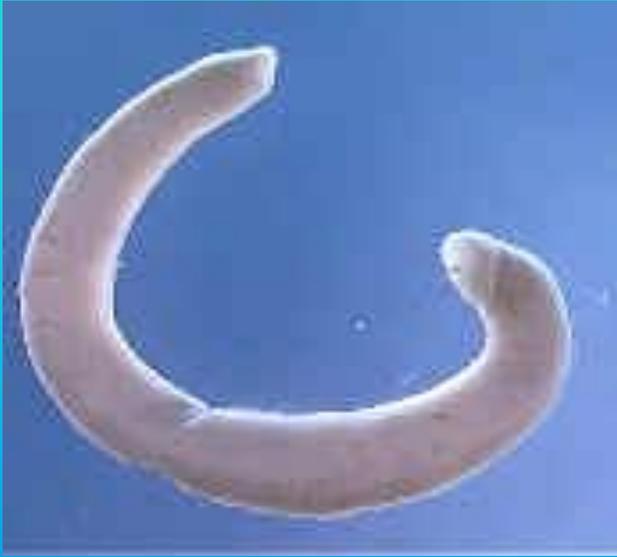
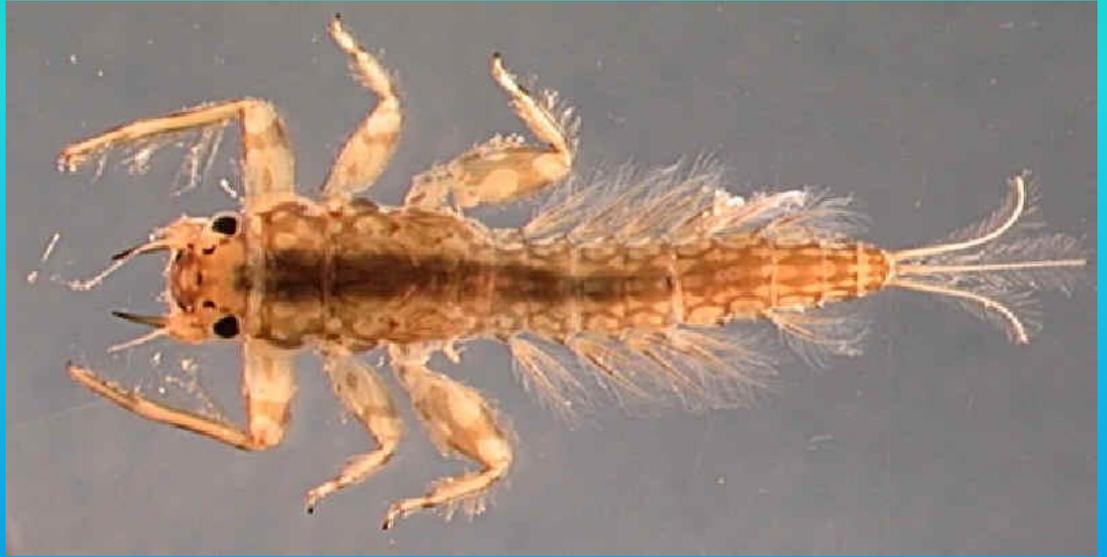
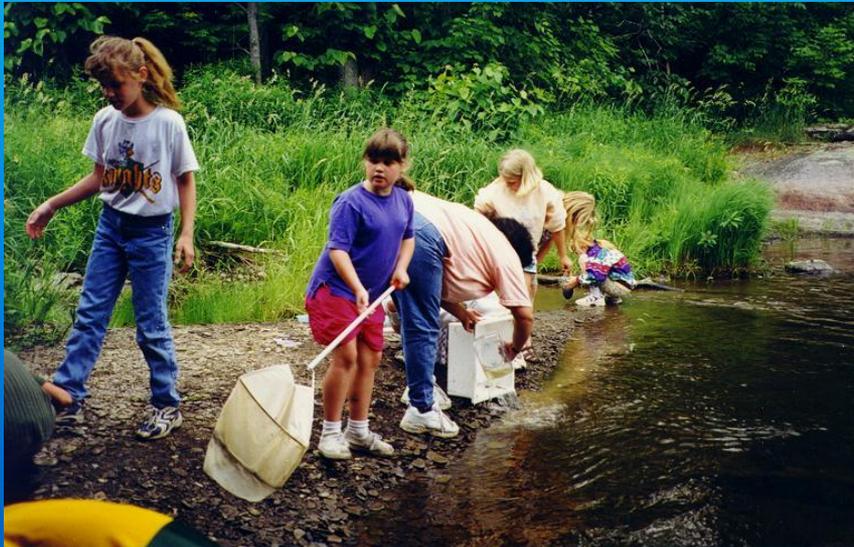
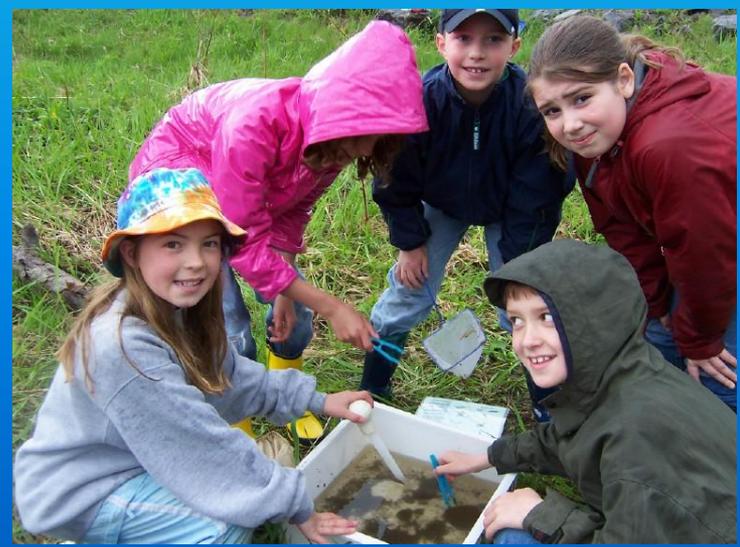
Stream Health Assessment

WQCC Macroinvertebrate Sampling

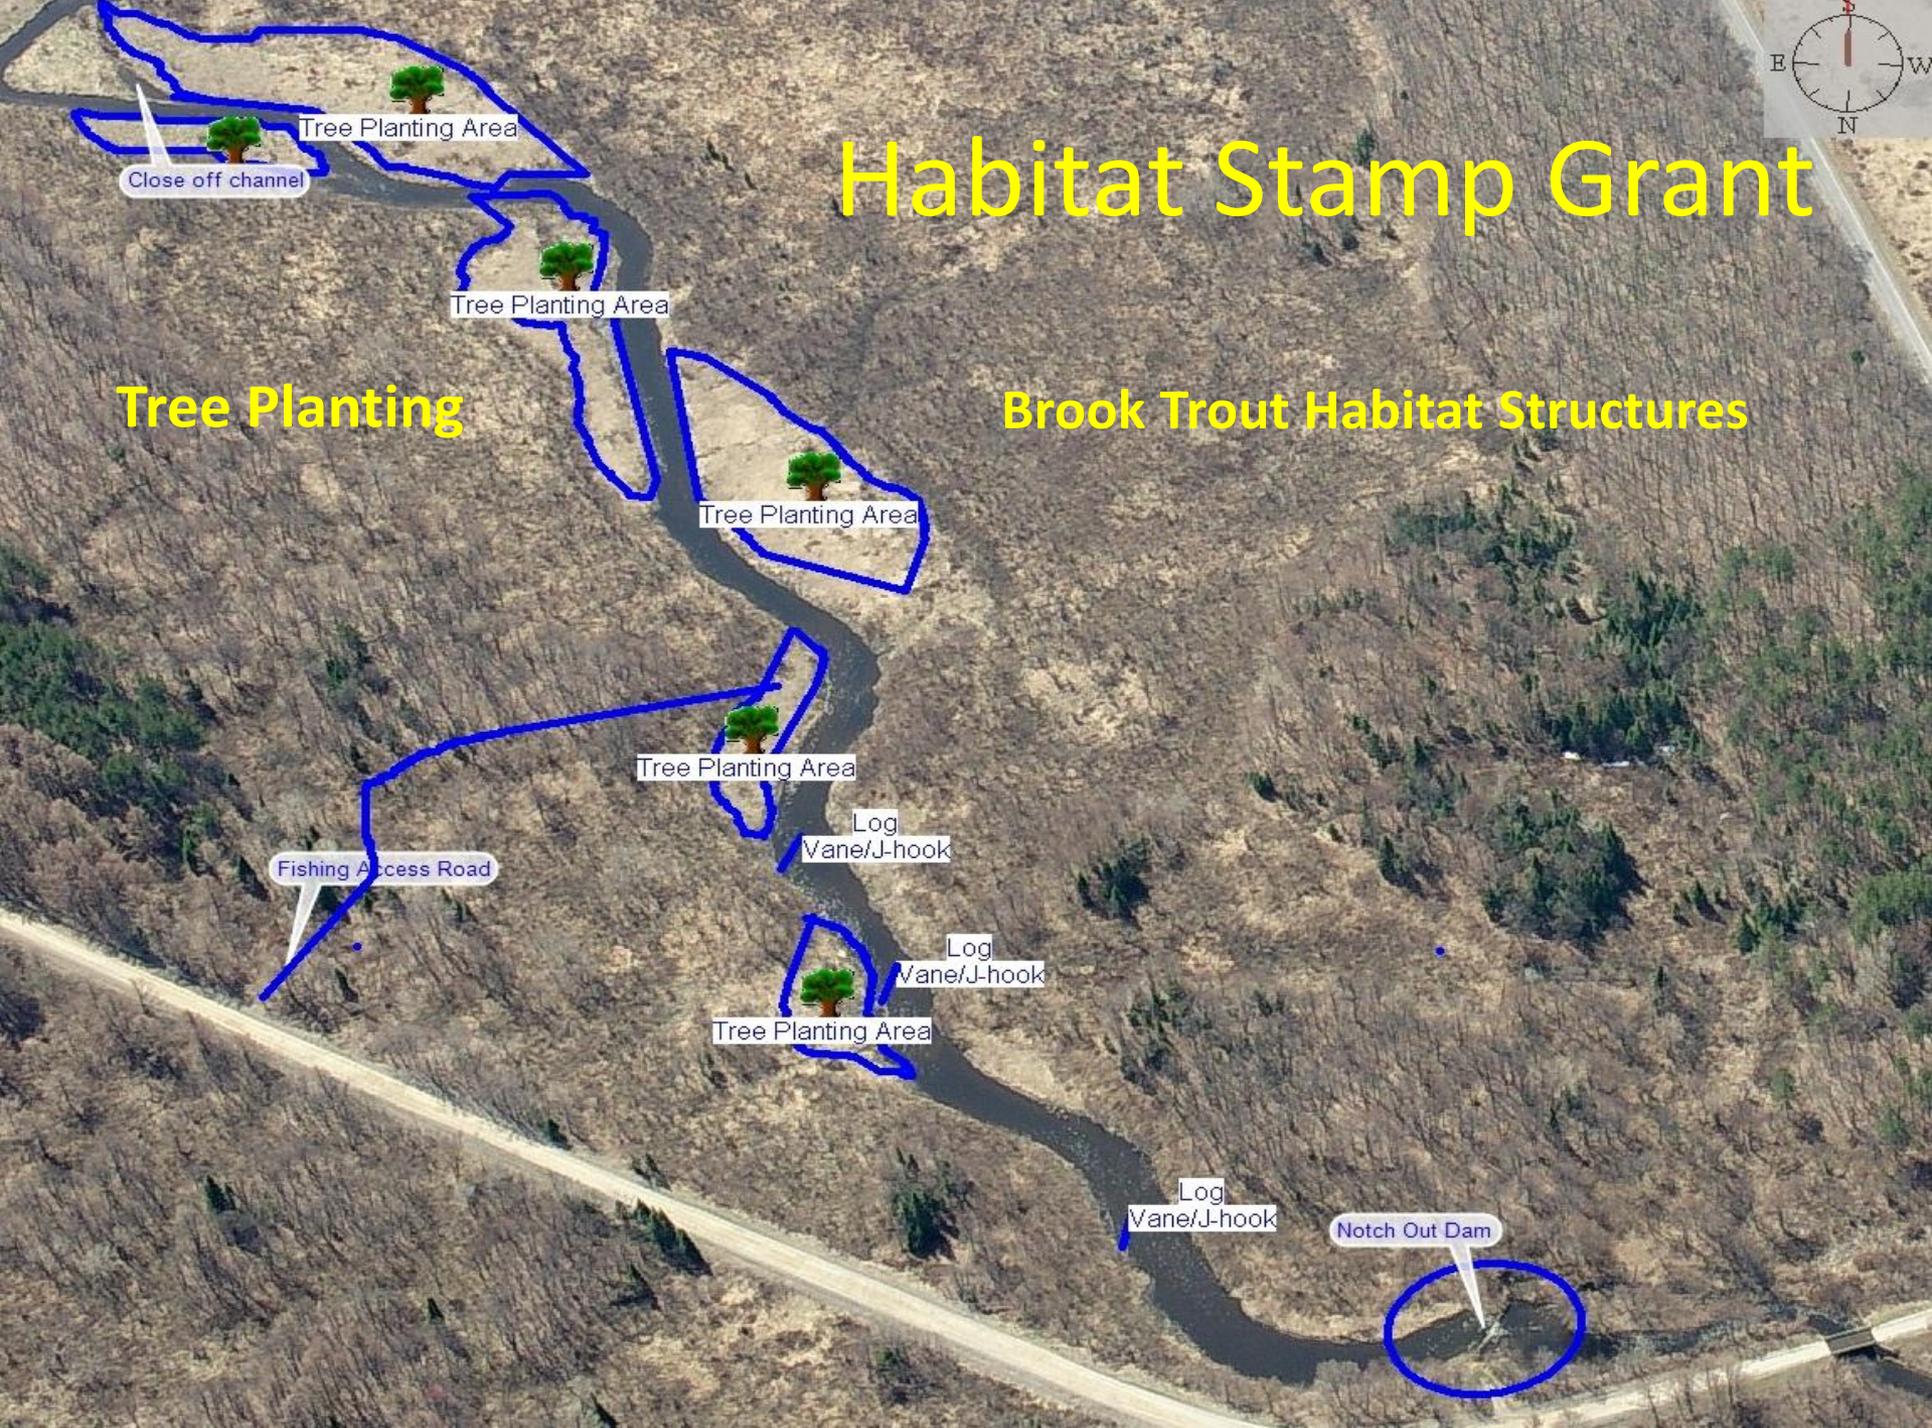
Tree Planting

Brook Trout Habitat Structures

Tree Planting Area

Close off channel

Fishing Access Road

Log Vane/J-hook

Notch Out Dam

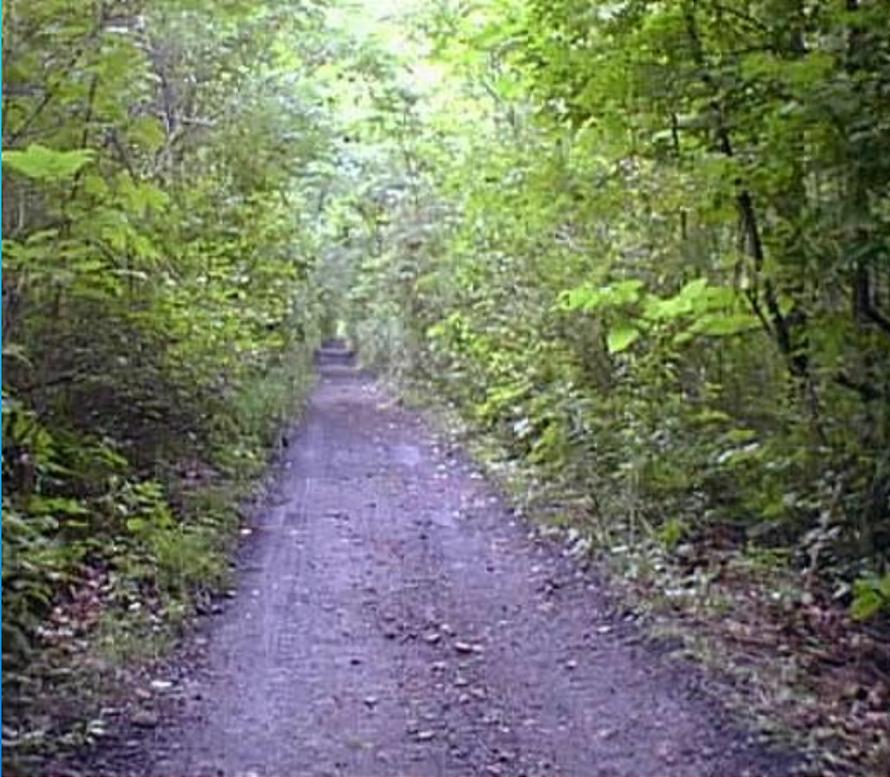
Trail Construction

- 4 Car Parking Lot
- Reduced to a Foot Trail
- Barricade for Non-Pedestrian Traffic
- Construction Minimize Disturbance (ground clearing, tree removal, etc.)
- Filter Fabric and Stone Placement

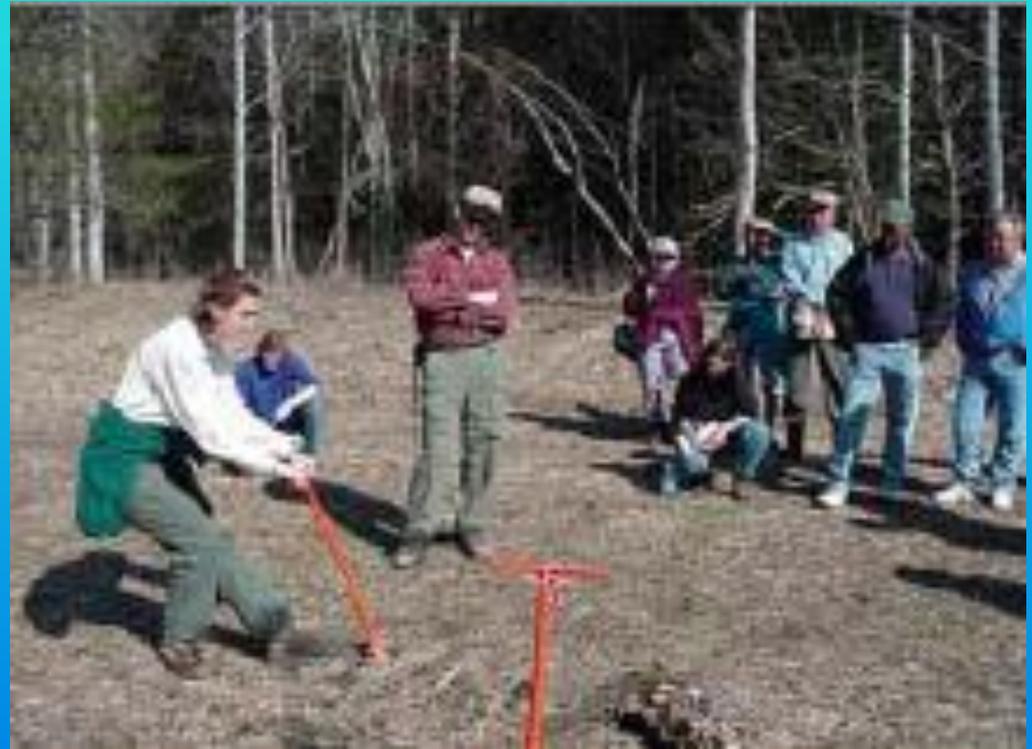
Tree Plantings (Flood Tolerant and Upland Species)

- Increase Shading
- Lower Water Temperatures
- Protect Streambank from Erosion

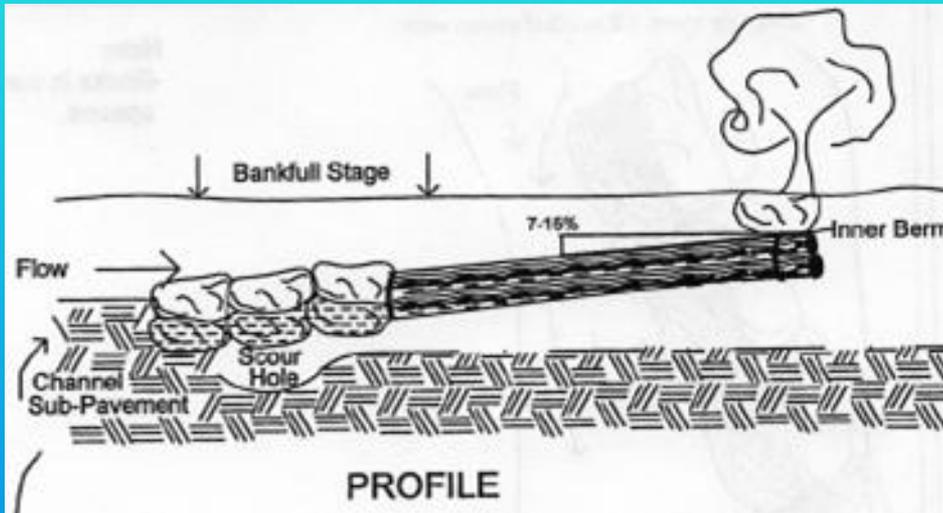
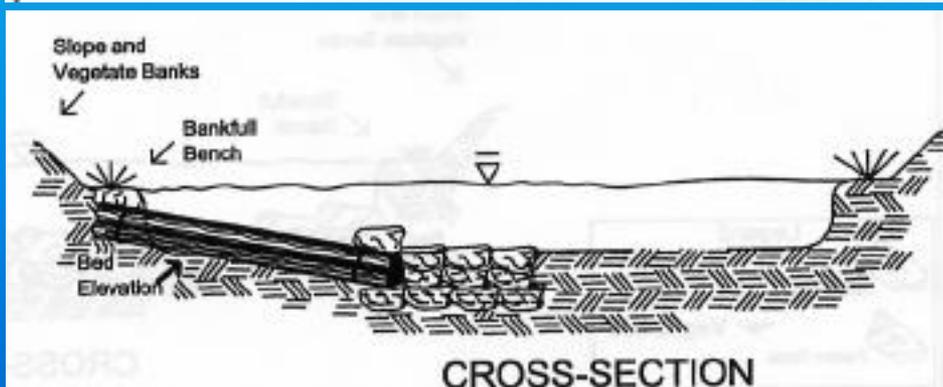
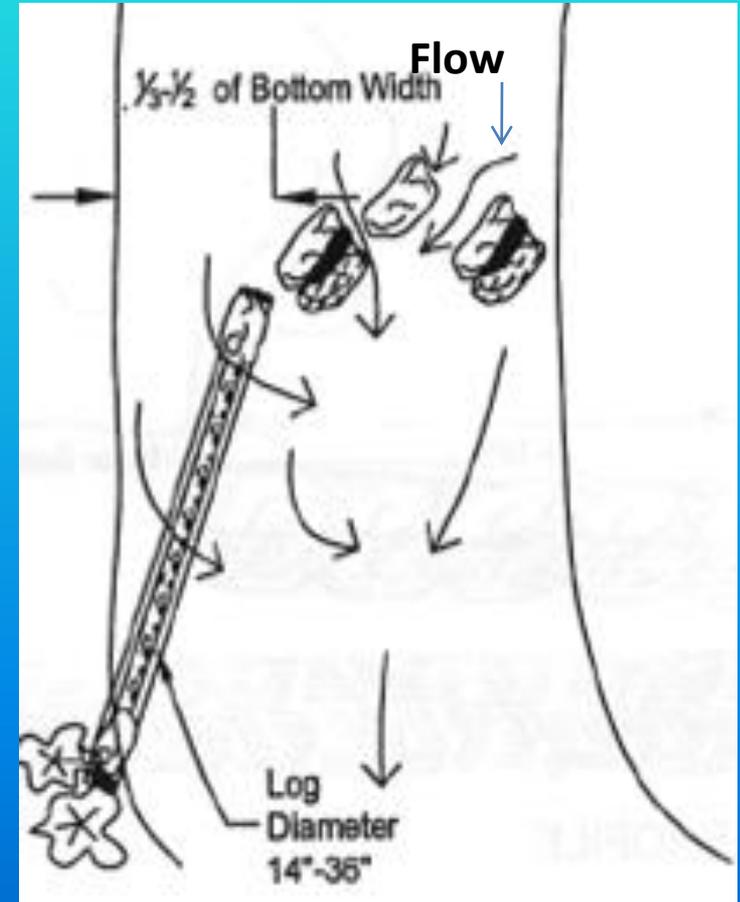
Log J-Hook Vane Detail

PLAN VIEW: LOG VANE

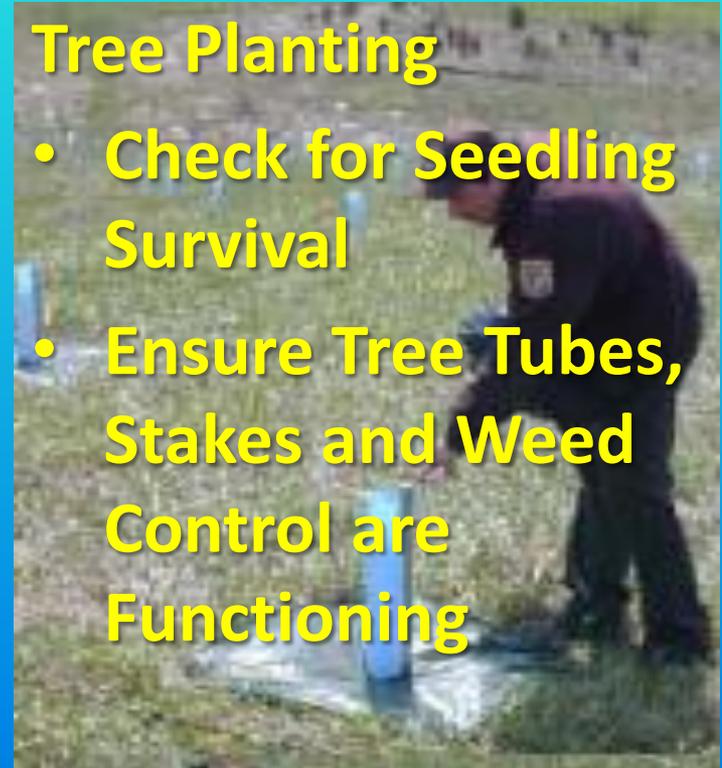
Tree Planting

- Check for Seedling Survival
- Ensure Tree Tubes, Stakes and Weed Control are Functioning
