Mohawk Solar

Towns of Canajoharie and Minden, Montgomery County, New York

Article 10 Application

Figure 23-2: Groundwater Aquifers and Recharge Areas

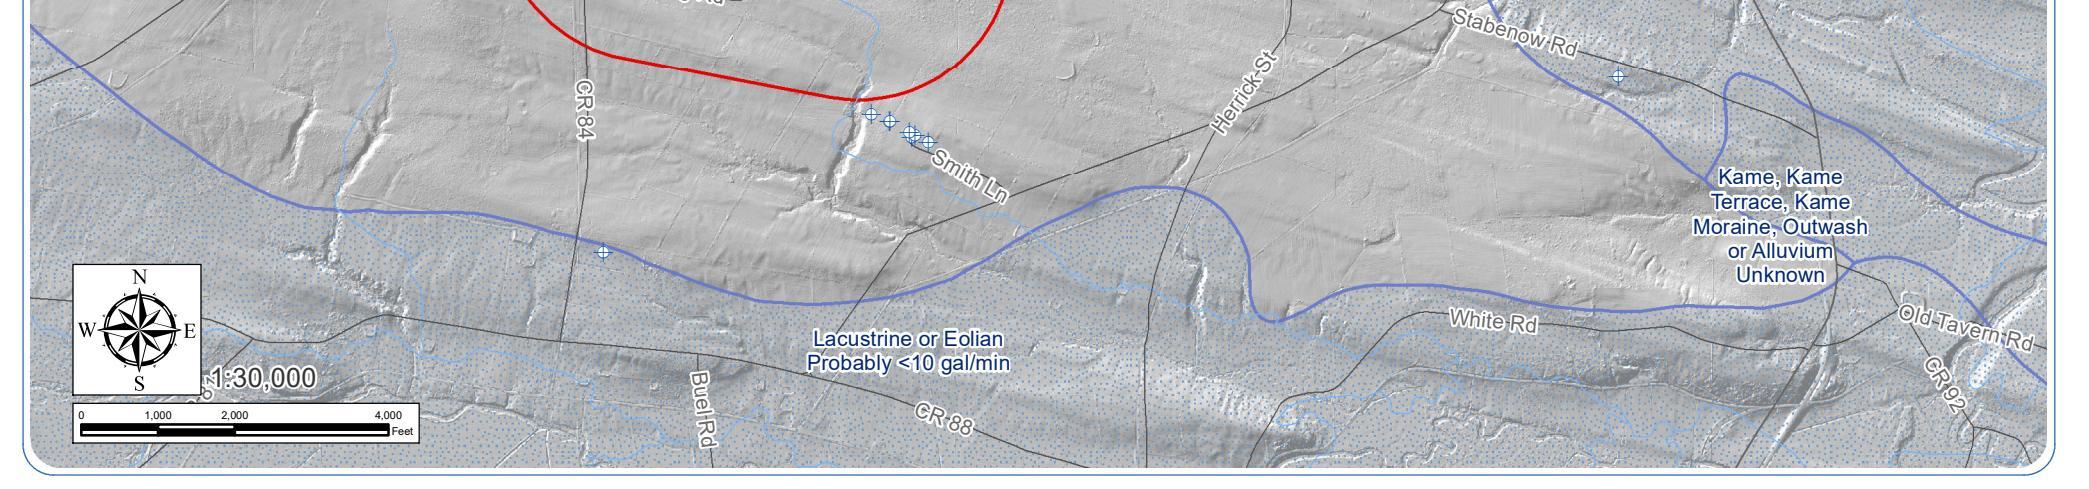
Groundwater recharge areas have not been mapped at this time. Direction of groundwater flow displayed herein is a simplistic interpretation based on the direction of stream Vellisto channel flow. According to the Preliminary Geotechnical Kame, Kame Terrace, Kame Assessment by Terracon, groundwater recharge areas are Moraine, Outwash typically present at local topographic highs, and or Alluvium groundwater discharge zones are typically present at local Unknown topographic lows within a groundwater sub-basin; however, groundwater flow direction and velocity are influenced by a number of additional factors. A more complete understanding of the groundwater conditions proximate to 80 -Dygert-S the proposed structures within the Facility Site would gert F require a more detailed and localized hydrogeologic study. Gare al Flow Direction 5 Kame, Kame Terrace, Kame Moraine, Outwash or Alluvium Unknown Lacustrine or Eolian Probably <10 gal/min Unconfined, High Yield >100 gal/min Unconfined, Mid Yield 10-100 gal/min General Flow Direction Lacustrine or Eolian Solf Club F Probably <10 gal/min -Flansburg-Rd-

Notes: 1. Basemap: Hillshade derived from 1-meter resolution DEM data, ESRI StreetMap North America, 2008. 2. This map was generated in ArcMap by Environmental Design and Research on May 16, 2019. 3. This is a color graphic. Reproduction in grayscale may misrepresent the data. 4. Groundwater recharge areas have not been mapped at this time.
